Operating Experience Weekly Summary 97-15

April 4 through April 10, 1997

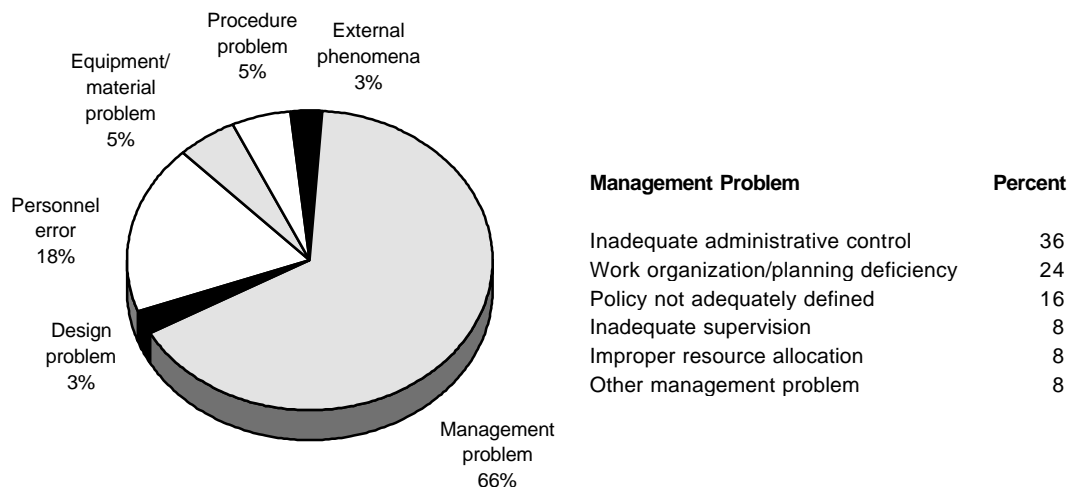
Figure 2-1. Distribution of Root Causes for Missed Surveillances¹

Operating Experience Analysis and Feedback (OEAF) engineers reviewed the Occurrence Reporting and Processing System (ORPS) database for missed or past-due surveillances and inspections across the DOE complex and found 38 occurrence reports. Figure 2-1 shows that facility managers reported management problems as the root cause for 66 percent of the occurrences. They also reported that personnel errors accounted for 18 percent of the occurrences. Further review shows that 36 percent of the management problems were reported as inadequate administrative control.

¹ OEAF engineers reviewed the ORPS database for Nature of Occurrence "1G" (unsatisfactory surveillance/inspections) and Narrative Search "miss@,schedul@" and found 97 occurrence reports. A 100 percent review of these reports yielded 38 reports for missed surveillance testing.

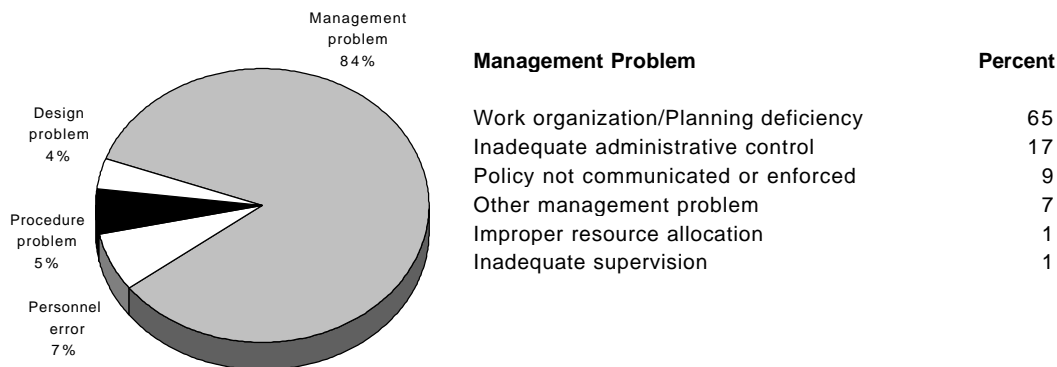
Figure 3-1. Distribution of Root Causes for Occurrences with a Direct Cause of Work Planning Deficiencies¹

Operating Experience Analysis and Feedback (OEAF) engineers reviewed the Occurrence Reporting and Processing System (ORPS) database for occurrence reports with a direct cause of work planning deficiencies across the DOE complex and found 403 reports. Figure 3-1 shows that facility managers reported management problems as the root cause for 84 percent of the occurrences. Further review shows that 65 percent of the reported management problems were caused by work organization and planning deficiencies.

¹ OEAF engineers searched the ORPS Graphical User Interface for Direct Cause "6B" (work planning deficiency) and found 403 reports.

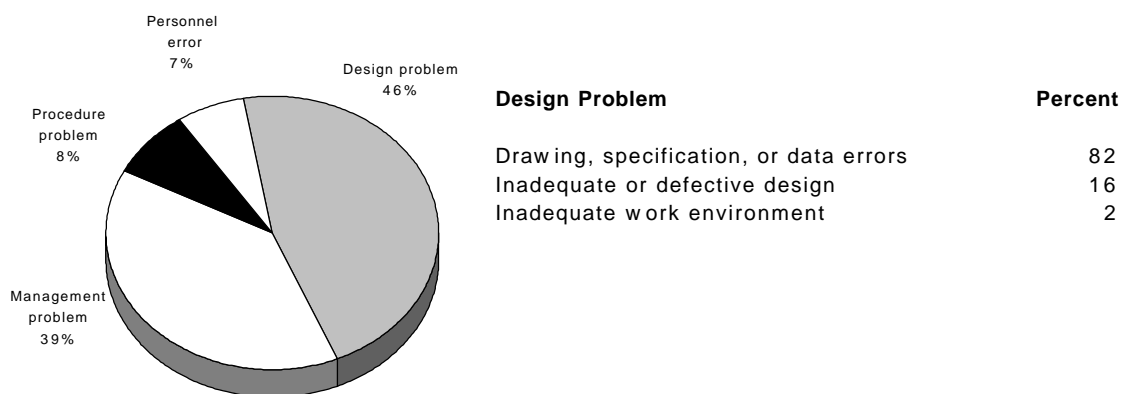
Figure 4-1. Distribution of Root Causes for Occurrences with a Direct Cause of Drawing, Specification, or Data Errors¹

Operating Experience Analysis and Feedback (OEF) engineers reviewed the Occurrence Reporting and Processing System (ORPS) database for occurrence reports with a direct cause of drawing, specification, or data errors across the DOE complex and found 200 reports. Figure 4-1 shows that facility managers reported design problems as the root cause for 46 percent of the occurrences. Further review shows that 82 percent of the reported design problems were caused by drawing, specification, or data errors.

¹ OEF engineers searched the ORPS Graphical User Interface for Direct Cause "4D" (drawing, specification, or data errors) and found 200 reports.
